ENGINEERING-SCIENCE, INC.

February 11, 1993

Subject: F33615-90-4014, Order 04,
O&M Effort for the Bioventing System at the 7th Street BX Service Station
(October through January 1993), Eglin, AFB

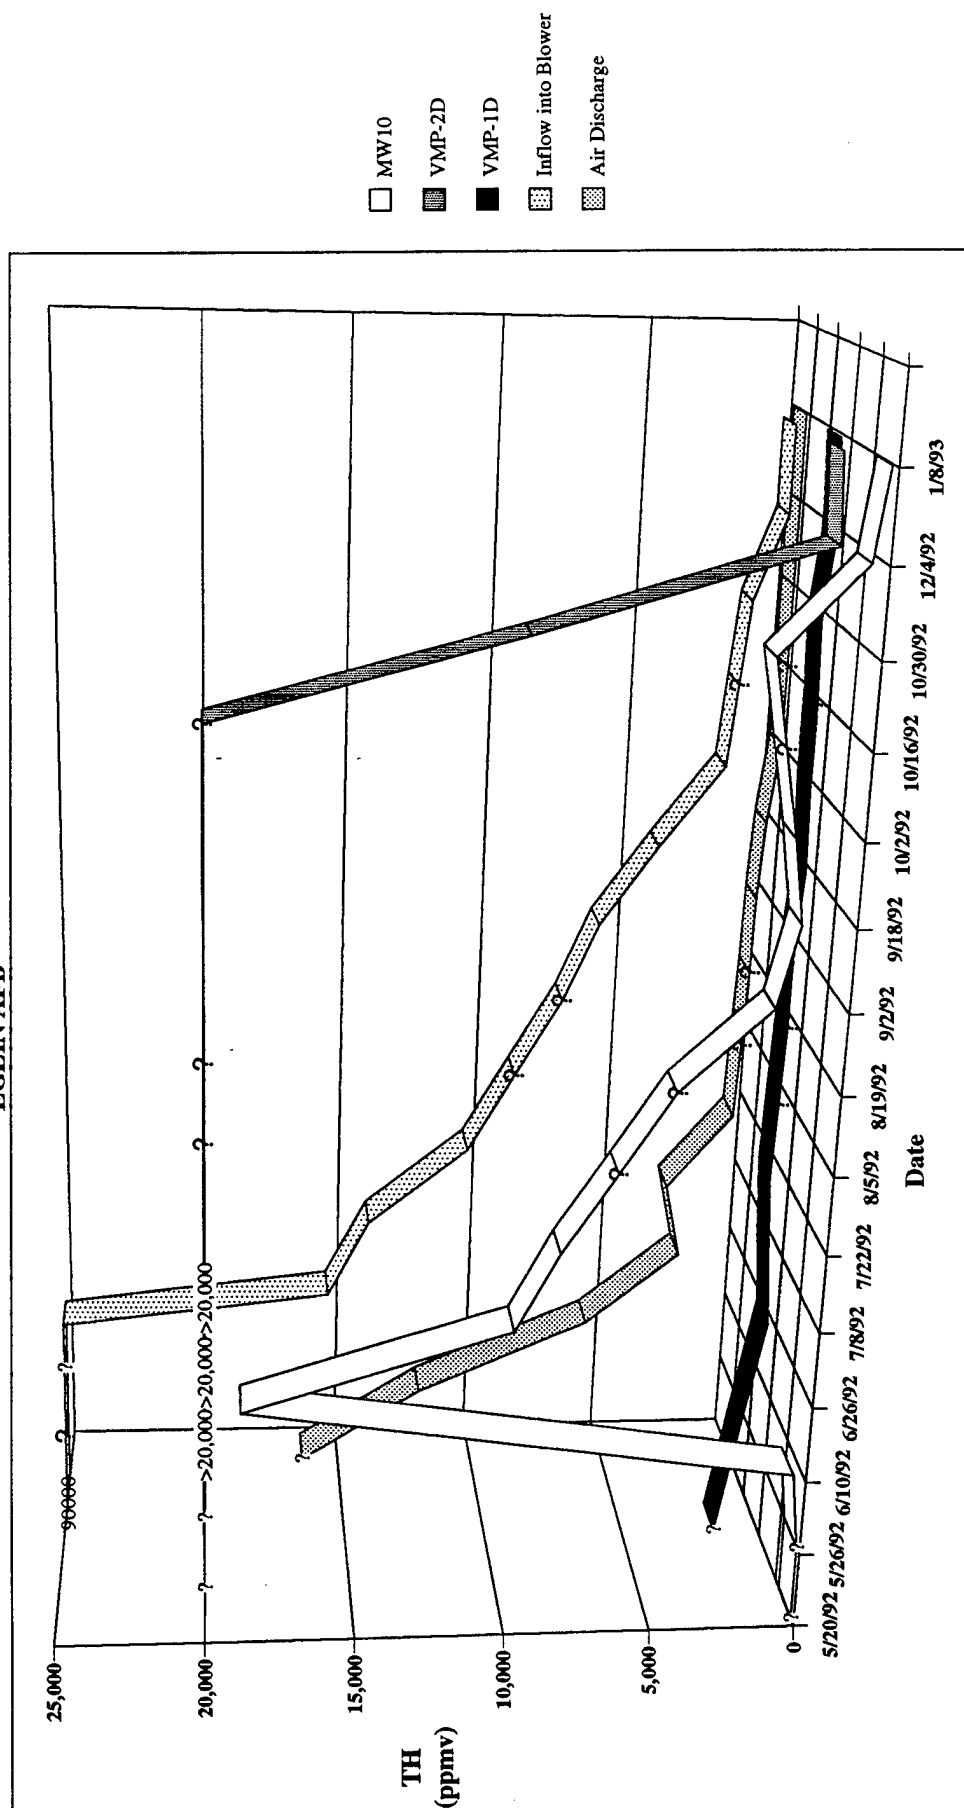
TOTAL HYDROCARBON LEVELS DURING BIOVENTING AT 7TH STREET BX SERVICE STATION (5/20/92 - 1/8/93) EGLIN AFB

Note: "?" indicates no data was recorded on this date; slopes are assumed to be linear.

Results of biweekly/monthly concentrations of oxygen, carbon dioxide and Total Hydrocarbons throughout the bioventing system are presented in Table 1 and depicted in the attached charts. These results continued to indicate increased biological activity in the subsurface and suggest potential increase in aerobic bacterial population. Results indicate oxygen supply to the subsurface has been adequately sustained. Notably, preventing condition indicated a soil oxygen concentration of zero at VMP-1 and VMP-2. As of January 8, oxygen concentrations at monitoring locations VMP-1, VMP-2 and MW-10 have increased to values ranging from 16.5 to 20.5 percent. In contrast, carbon dioxide which was in excess of 15 percent prior to startup has declined to values ranging from 2.0 to 8.0 percent at all monitoring points. Available data indicate a rapid decline in total hydrocarbon concentration over the past two months (December and January). Volatilization and to a greater extent biodegradation are believed to be responsible for the total hydrocarbons removed.

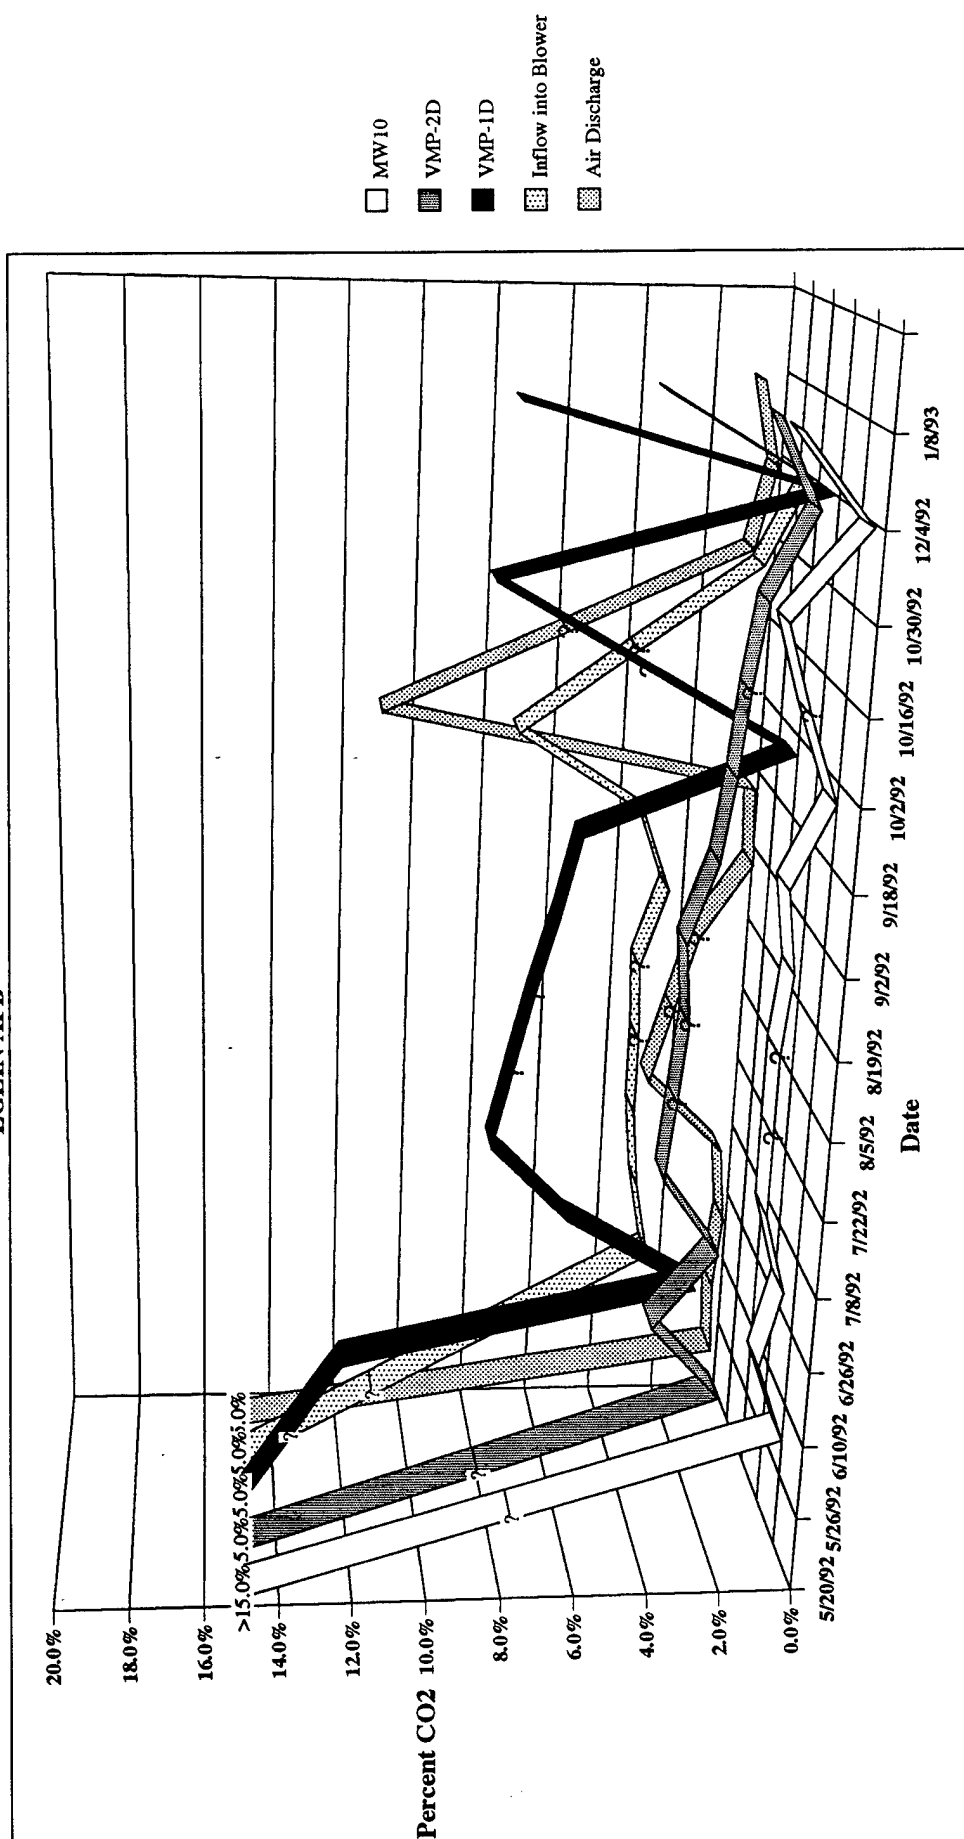
Figure 1

CARBON DIOXIDE LEVELS DURING BIOVENTING AT 7TH STREET BX SERVICE STATION (5/20/92 - 1/8/93) EGLIN AFB

Note: "?" indicates no data was recorded on this date; slopes are assumed to be linear.

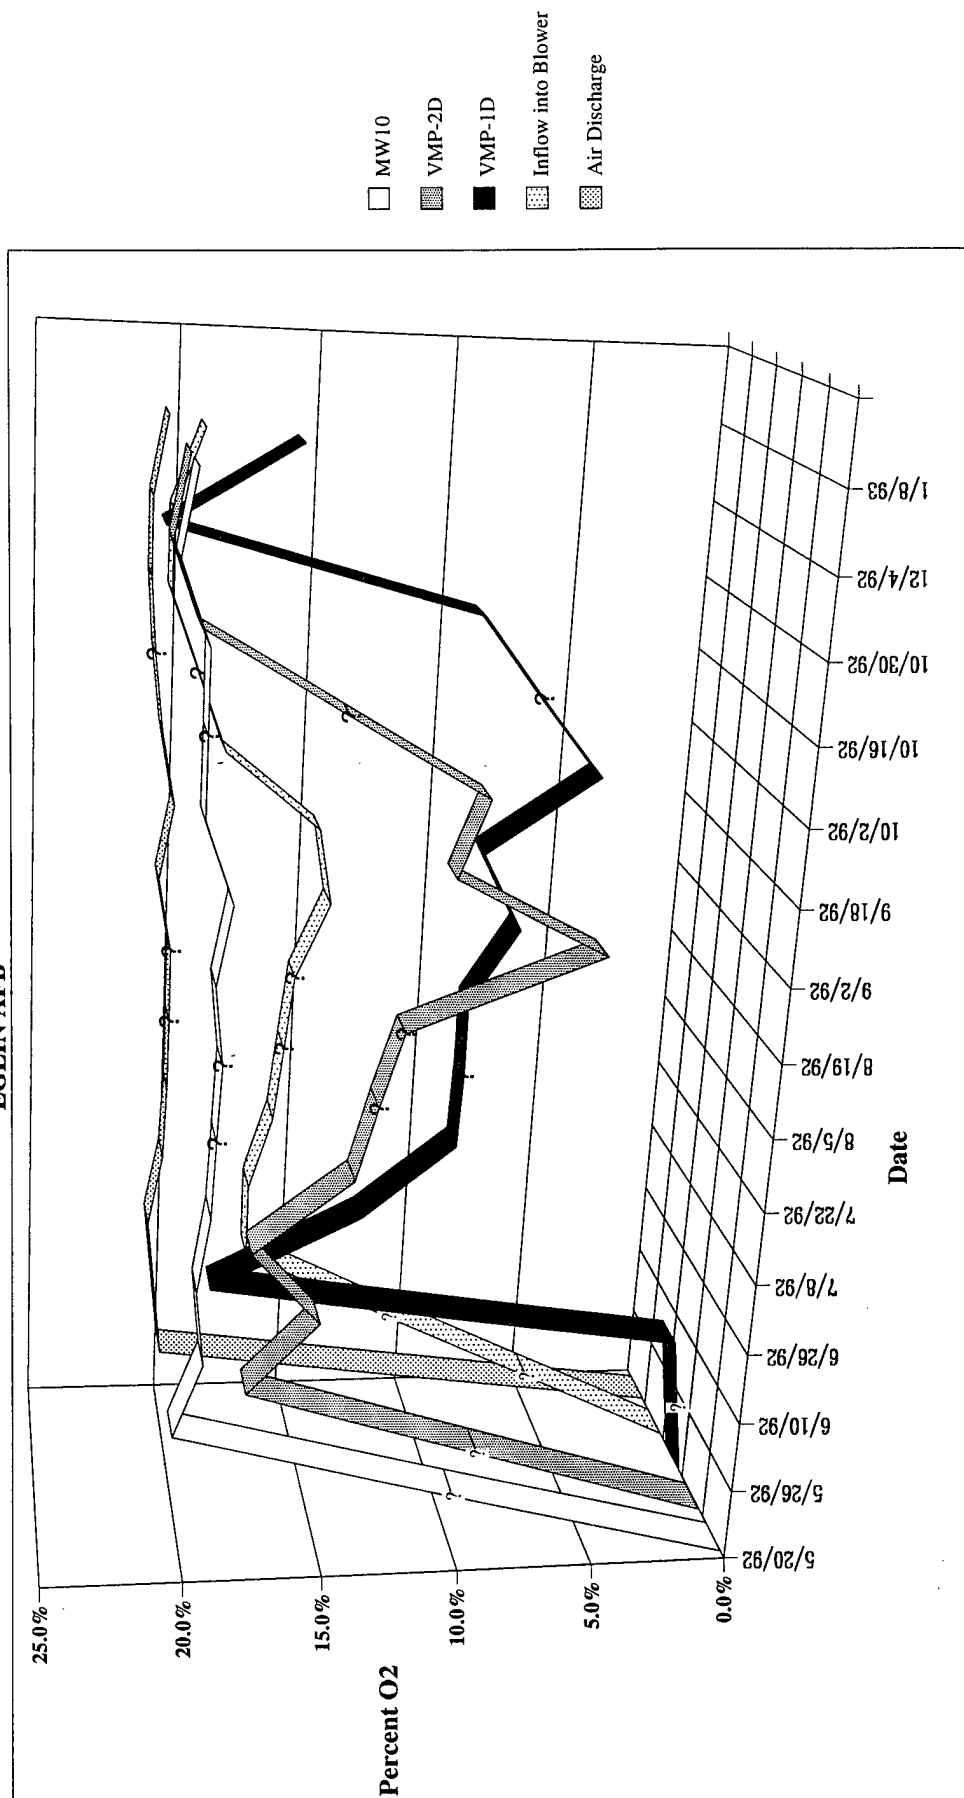
OXYGEN LEVELS DURING BIOVENTING AT 7TH STREET BX SERVICE STATION (5/20/92 - 1/8/93) EGLIN AFB

Note: "?" indicates no data was recorded on this date; slopes are assumed to be linear.

(1) - Baseline background conditions were: Oxygen - 20.4%, Carbon Dioxide - 0.6%.
